DESKTOP APPRAISAL OF A GENERAL AVIATION AIRCRAFT

1962 Beech Baron 95-A55

Registration N20TY, Serial Number TC-254

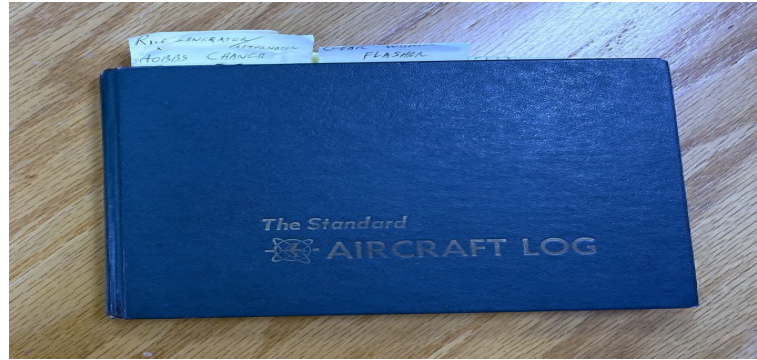
The Colemill Presidential II kit was installed on the Subject Aircraft around **May 1, 2003** as per the Aircraft Log book below. Presidential II Conversion causes the subject aircraft to be more powerful with the (2) new 300hp engines; and can fly longer distances without refueling due to the winglets (superior performance) plus long range fuel tanks (30 extra gallons).

Aircraft Log was reviewed Appraiser.

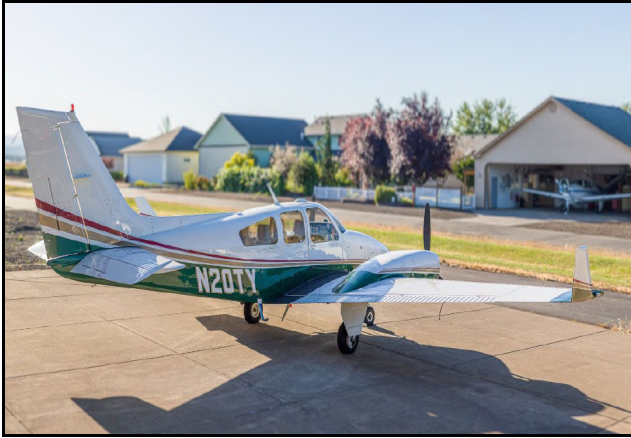
Left Photo: View of right side/rear of fuselage. *Note:* winglets, N-number, good exterior paint, wing surfaces, large windows, strip painting, all in very good condition and stored in an enclosed hanger.

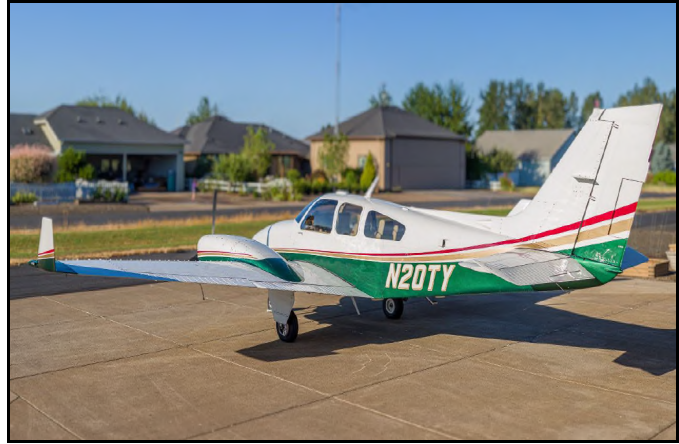
Right Photo: View of left side/rear of fuselage. *Note:* winglets, forward instrument compartment access, windshield (no cracks), wipers, wing (no paint peeling paint), landing gear, front landing gear/ wheel are all in very good condition.

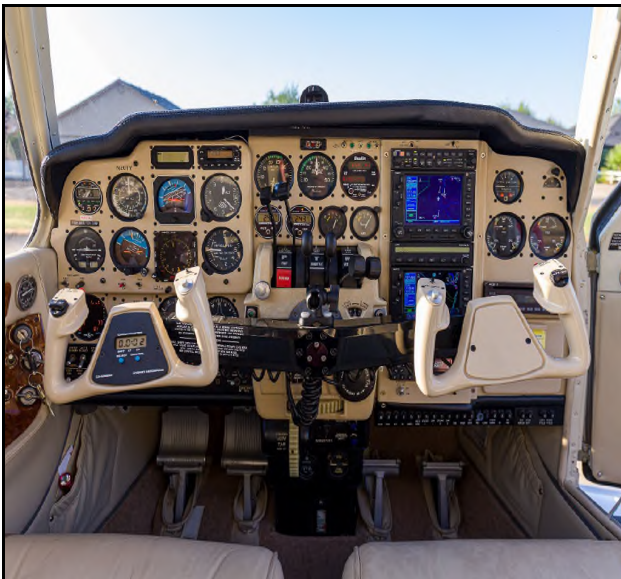
Left Photo: View of updated cockpit. *Note:* digital avionics, high head clearance, modern hard plastic interior, large side window/wind shield, modern control yoke, good avionics containing required instruments, switches and gauges; newer upholstery, carpet, all in very good condition.

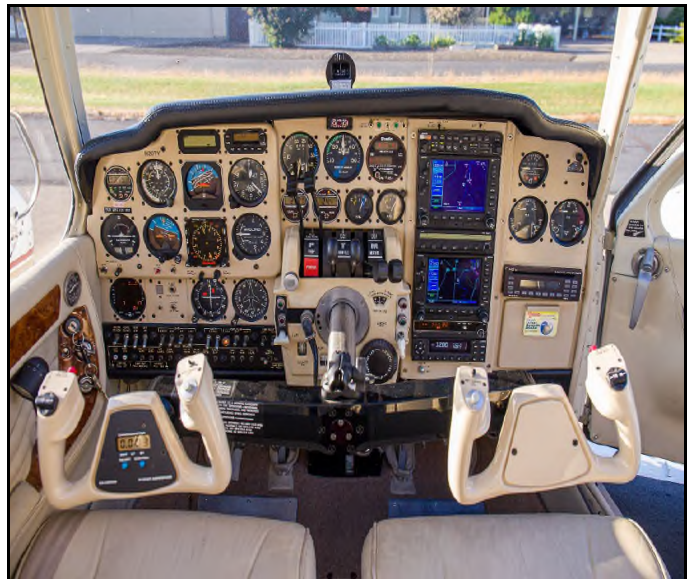
Right Photo: View of update cockpit. *Note:* high head clearance, modern hard plastic interior, large side window/wind shield, modern control yoke, adequate avionics containing required instruments, switches and gauges; adequate upholstery, carpet, all in very good condition.

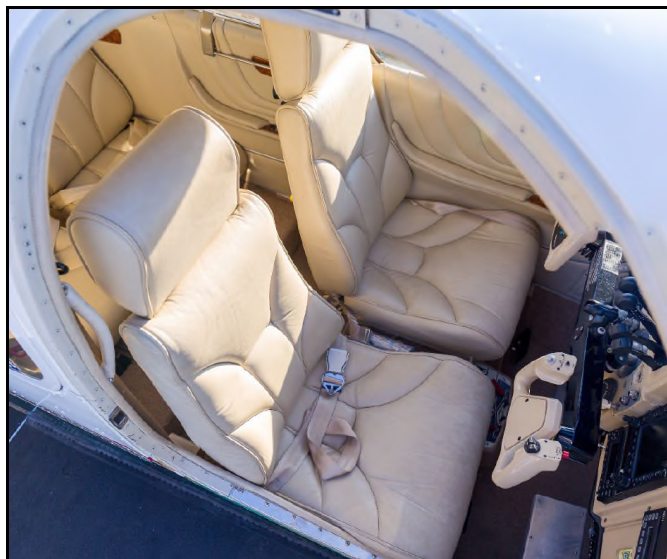
Left Photo: View of cockpit seats. *Note.* Very good condition large adjustable new leather seats, tightly woven carpet, adequate leg room, all items in very good condition.

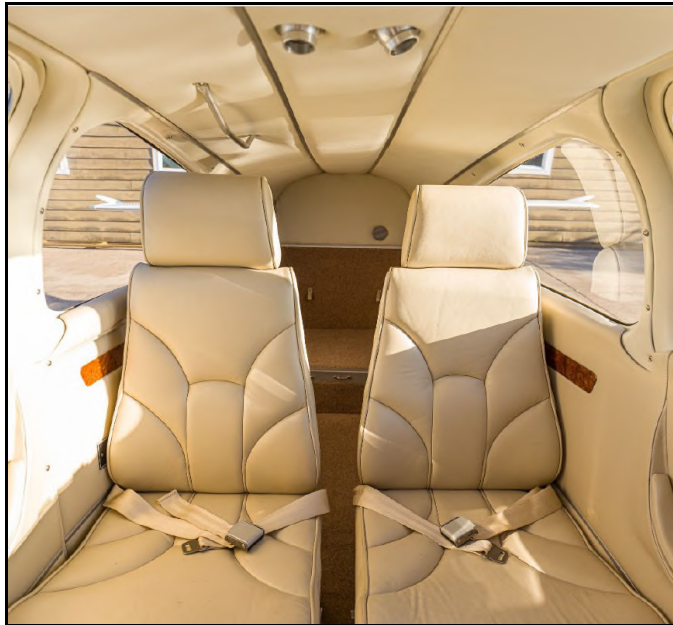
Left Photo: View of interior passenger cabin. *Note:* large adjustable leather seats, pull-out tables, curtains, tightly woven carpet, adequate leg room, pull bar in ceiling, all items in very good condition.

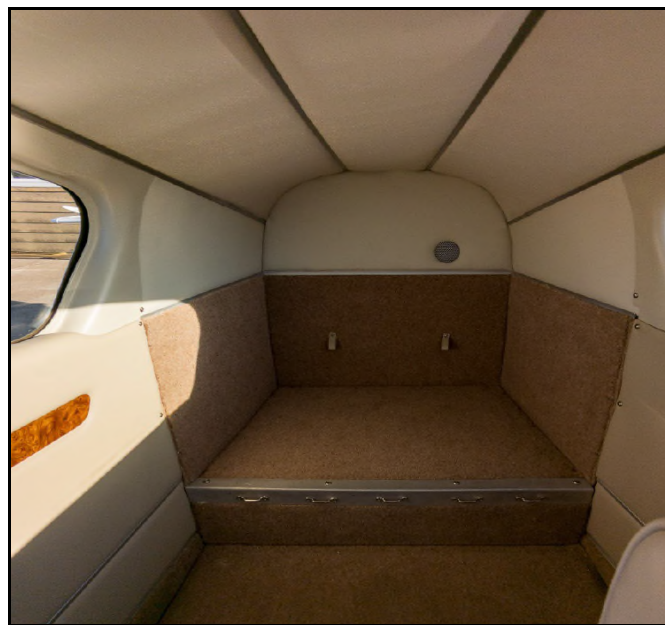
Right Photo: View of interior passenger cabin. *Note:* [interchangeable use: can add two small child seats or use as luggage compartment making seating capacity 6 instead of 4], tightly woven carpet, shelve space, all in very good condition. Owner has extra two seats available.

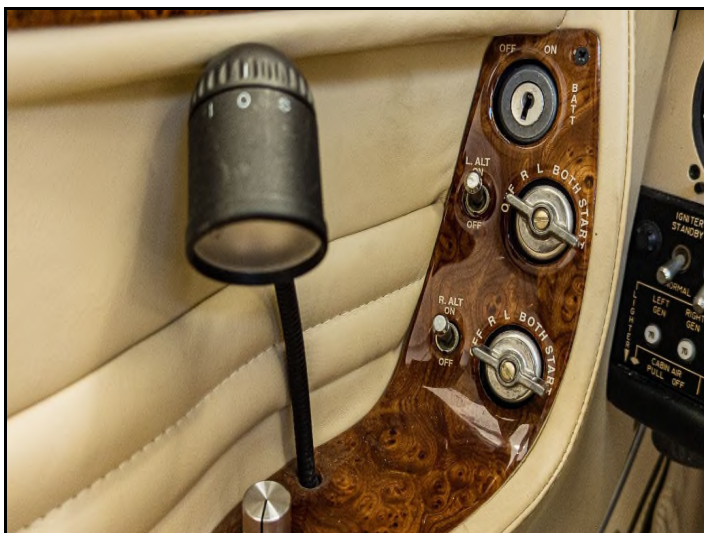
Left Photo: View of cockpit upholstery and instrumentation. *Note:* adequate lights, space, soft leather walls, hard paneling all in very good condition.

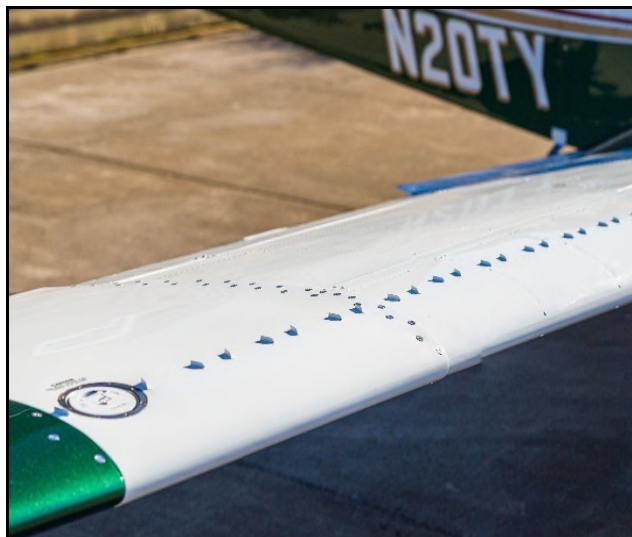
Right Photo: View of wing. *Note:* smooth surface alignment and no signs of paint corrosion.

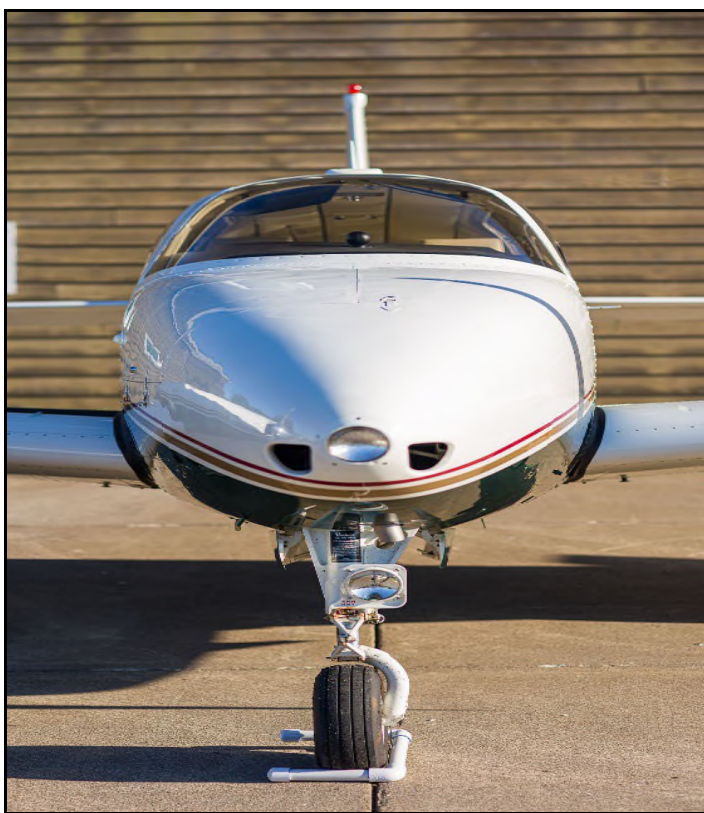
Left Photo: View of wheel, lights and landing gear. *Note:* 3 bladed propellers, new tire, clean joints and no oil leaks.

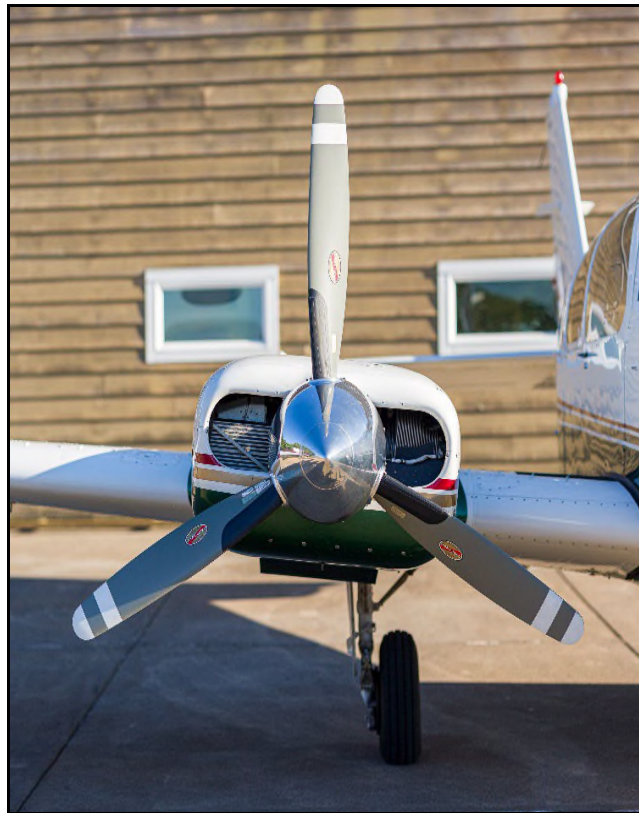
Right Photo: View of right engine cowling and propeller: no signs of paint corrosion, scratches or wear on any surfaces.

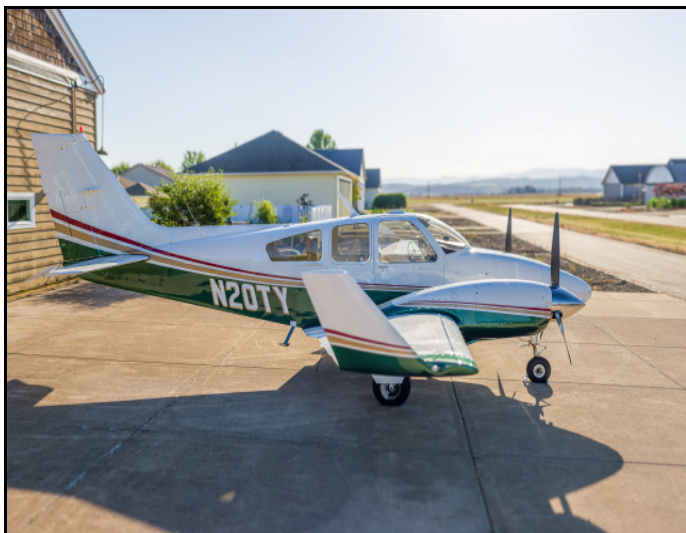
Left Photo: View of side. *Note:* winglets, new paint, no dents, roll/parked position balanced.

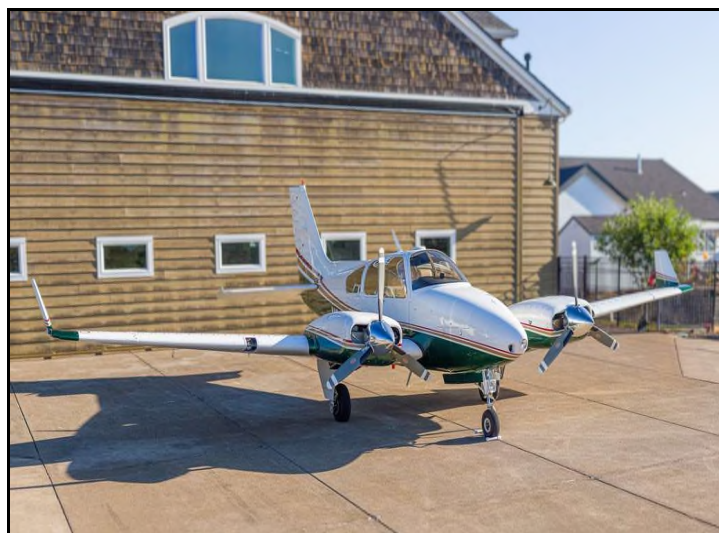
Subject Aircraft: Side, Winglets, Personal Hanger and Navigation Lights

Right Photo: View of personal hanger and front. *Note:* large hanger where plane is kept (most of the time), climate controlled and watertight.

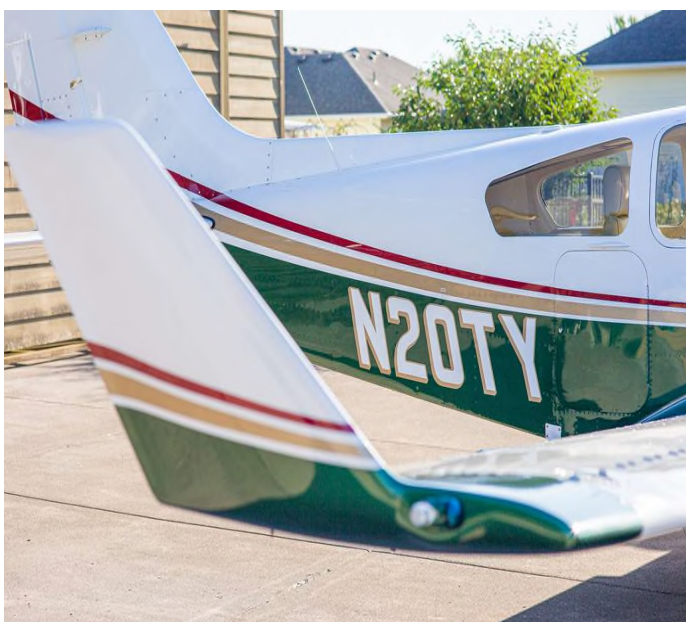
Left Photo: View closeup of winglets, lights and paint cover. *Note:* new winglets (15gal each) plus increased performance, smooth clean surface, adequate lights and no dents or chipped paint.

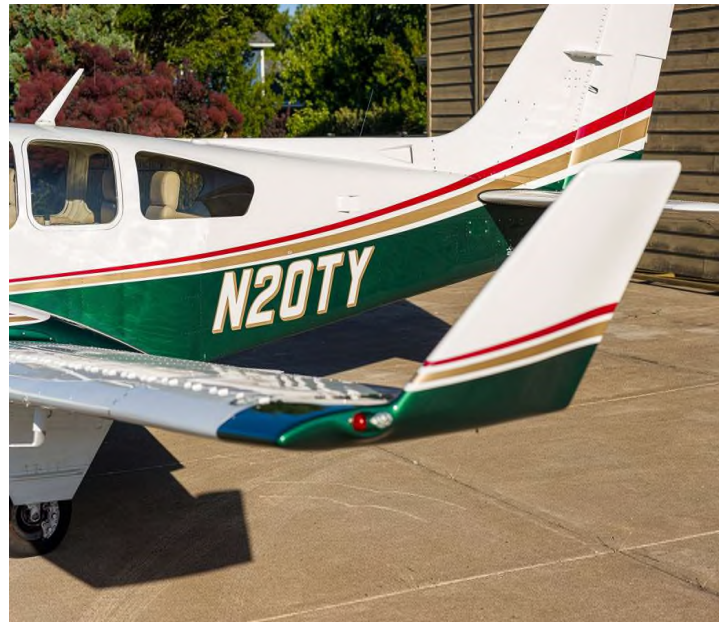
Right Photo: View winglets, lights and paint cover. *Note:* new winglets (15gal each) plus increased performance, smooth clean surface, adequate lights and no dents or chipped paint.

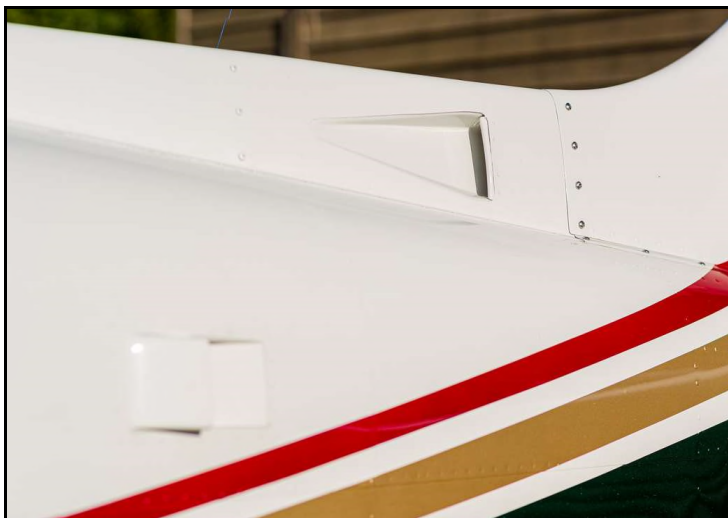
Left Photo: View of side. *Note:* new paint, no dents.

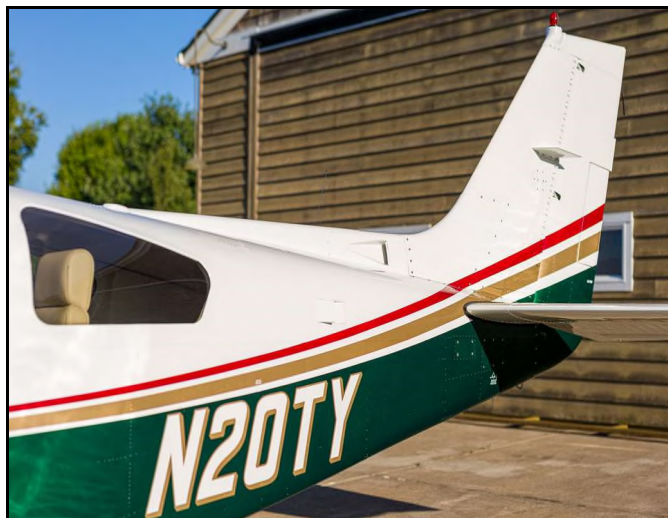
Right Photo: View of rear side. *Note:* new paint, no dents.

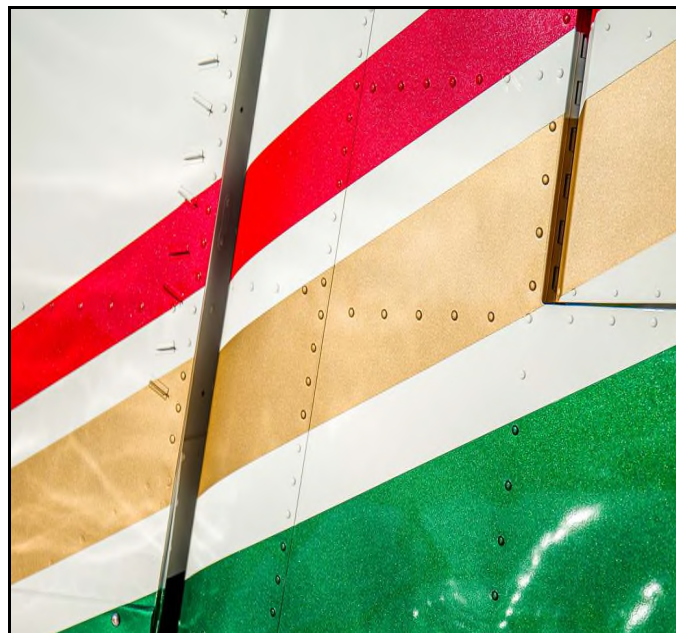
Right Photo: View sheet metal covering and fasteners. *Note:* smooth clean surface, no cracks or seam gaps, with new tight rivets.

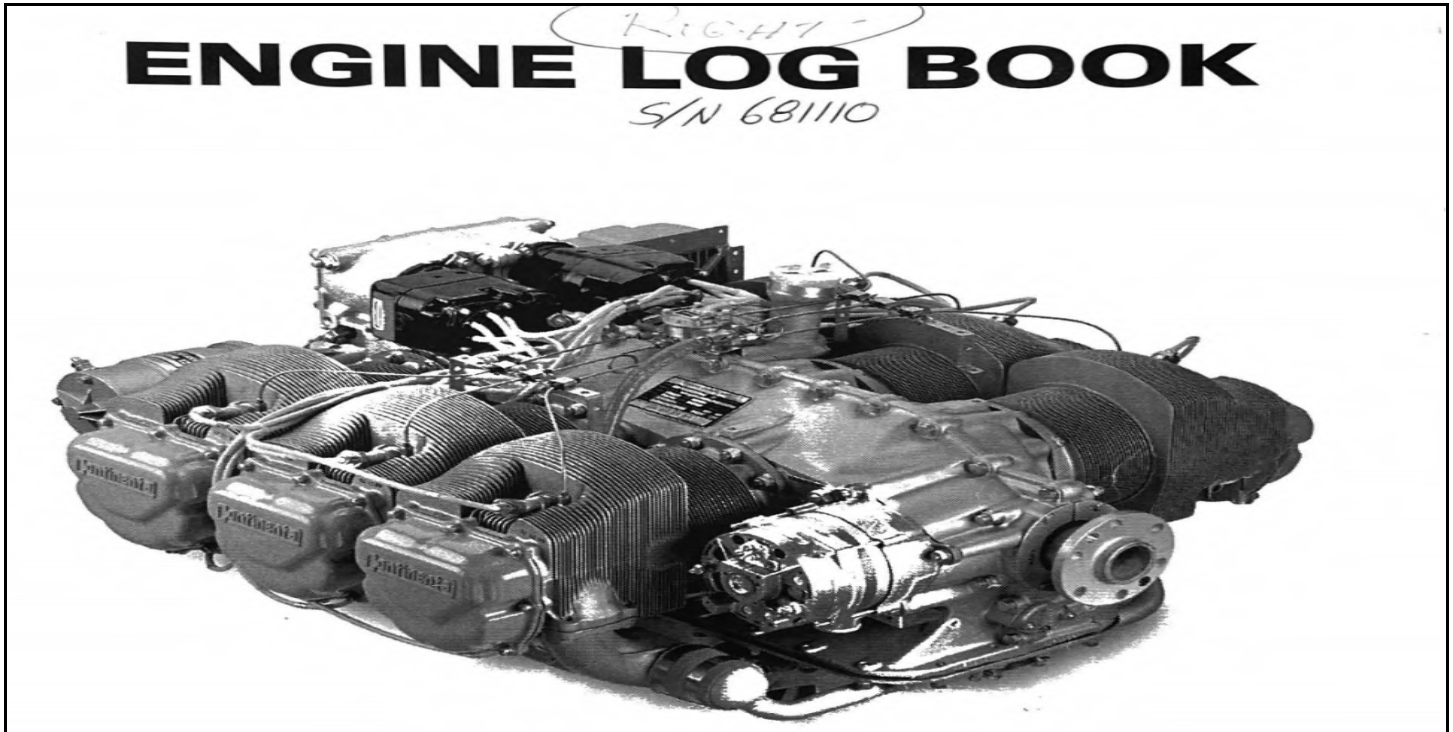
Subject Aircraft: Right Engine

Aircraft Engine Test Verification				Engine Service and Maintenance Record			
Date		Total Time		Time Since Last Overhaul		Installations, Inspections, Airworthiness Directives, Special Inspections, Modifications and Service Bulletins	
		Hrs.	Min.	Hrs.	Min.		
				COLEMILL ENTERPRISES, INC. N20TY			
DATE: 05-06-03				ENGINE T.T.S.N.: 00.0		HOBBS: 0901.3	
Installed this engine Model IO-550-E, S/N 681110 on the Right hand side of BEECH B-55 s/n TC-254. Engine was new at time of installation. Serviced engine with 12 Qts. Aeroshell oil 100. Baffling and seal material was repaired or replaced as required. Replaced all engine mounts and hoses with new units. Refer to serialized component list for details of installed components at this time. Installed new air, Pneumatic filters. Installation was accomplished in accordance with STC SA 43250. Engine was ops checked and ground run and checked for leaks. I certify this ENGINE has been inspected in accordance with A ANNUAL. Inspection and found airworthy for return to service.

3/3/21	MEL-21-03	N/A	by	1449	date	of engine	Wendy Harold	APP 35059
5/10/2022	N20TY	Hobbs 1273.4	TTE 372.1					
Compression test #170/80 #2 72/80 #3 71/80 #4 71/80 #5 74/80 #6 70/80. Changed oil and filter added 12 qts AeroShell W100 and 1 CH48108 filter. Inspected old filter for contaminants found none. Accomplished AD 2022-04-04 replaced fiber gaskets with AN900-28 crush gaskets on oil filter adapter as per Stratus service bulletin SB-001 rev B. Checked mag timing, tested sparkplugs. I certify that this engine has been inspected IAW an annual inspection and is in airworthy condition.								
<i>Dana R Harold</i> 3365930IA
